Comparative tests between products with UV powder paint and products with standard powder paint

1 PURPOSE

In the **first part** will be verified the different characteristics in terms of mechanical resistance and the different properties between a standard polyester painting and a crosslinking painting induced by UV irradiation, applied on steel sheets.

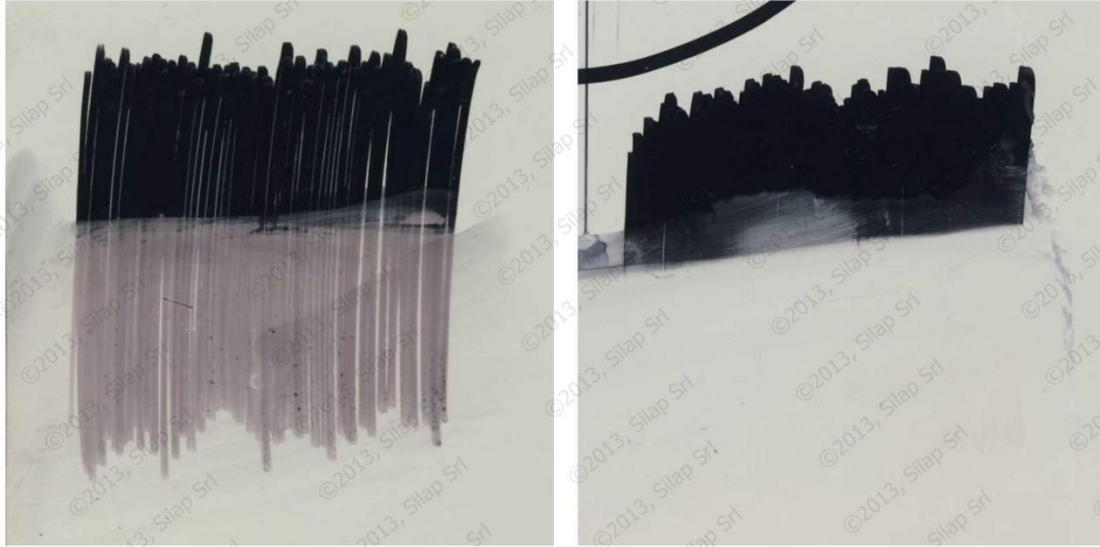
GRAFFITI-PROOF TEST AFTER 1 WEEK

The surface was scrawled with a marker PEN PENTEL N50 and was briefly cleaned by wiping with a cloth soaked in solvent. Here are the results of that test.

Picture 2 - On the left: A sample cleaned with solvent after 1 week; On the right: sample B cleaned with solvent after 1 week

Sample B (UV paint) has no marker residues, so has better water resistance than conventional paint, thanks to the UV curing which makes the piece less permeable.

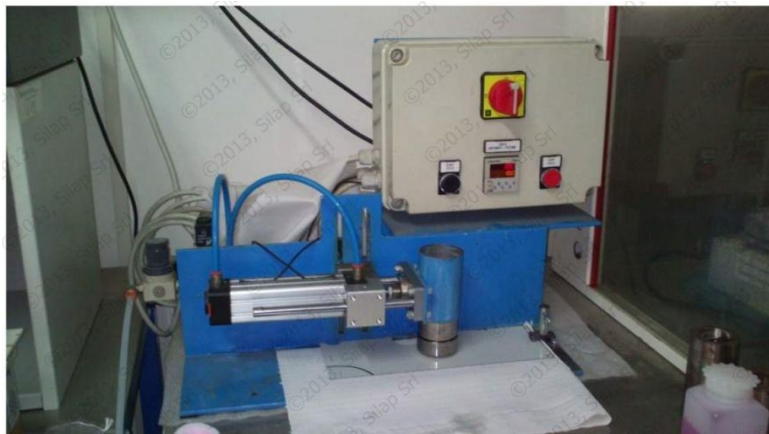
The test was performed by subjecting the samples to continuous passages of a swab soaked in solvent maintained in contact with the surface by a mass of 1 kg.

Picture 3 - Equipment for solvents test

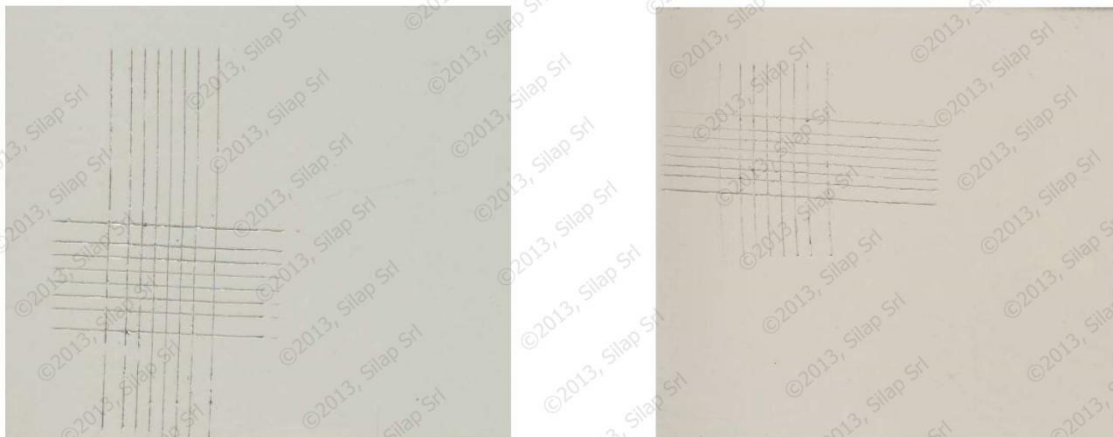
The test was performed according to **EN ISO 2409:1996**. The results obtained after the cross-cut test are reported in the table.

Reference	Thickness	Result	Notes
Sample A (standard paint)	80 µm	0 (no separation)	-
Sample B (UV paint)	85 µm	0 (no separation)	-

Picture 4 – Cross-cut test results, on the left the sample A, on the right the sample B

This test gave the same result for both samples, but the realization of the incisions was more difficult on the sample B because the UV coating is much more resistant than standard paint of the sample A.

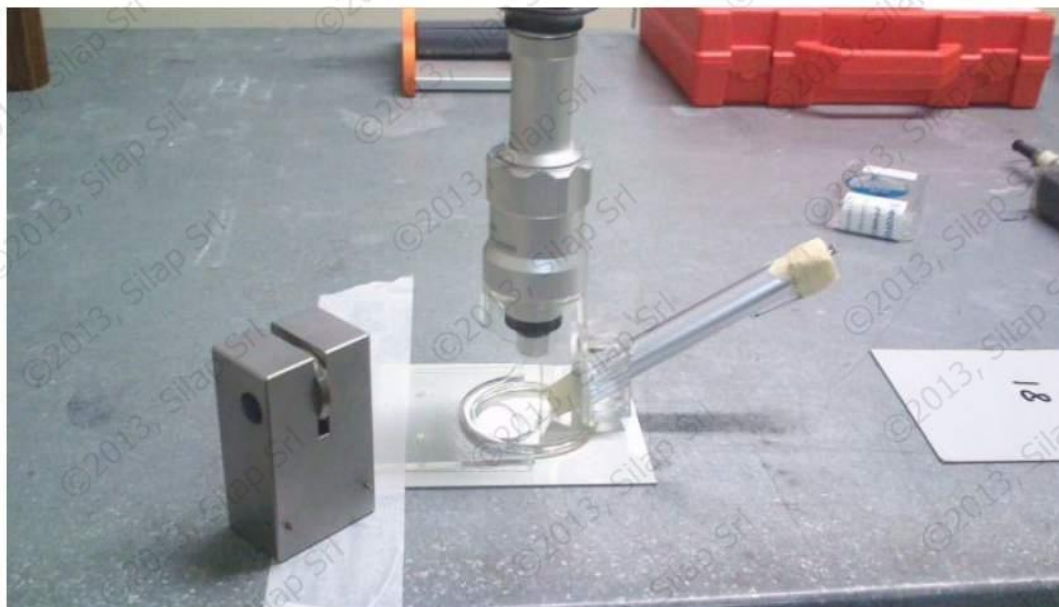
The test was performed according to ISO 2815. Both samples gave the same value as hardness index, equal to 111.

Picture 5 – Buchholz hardness test machine

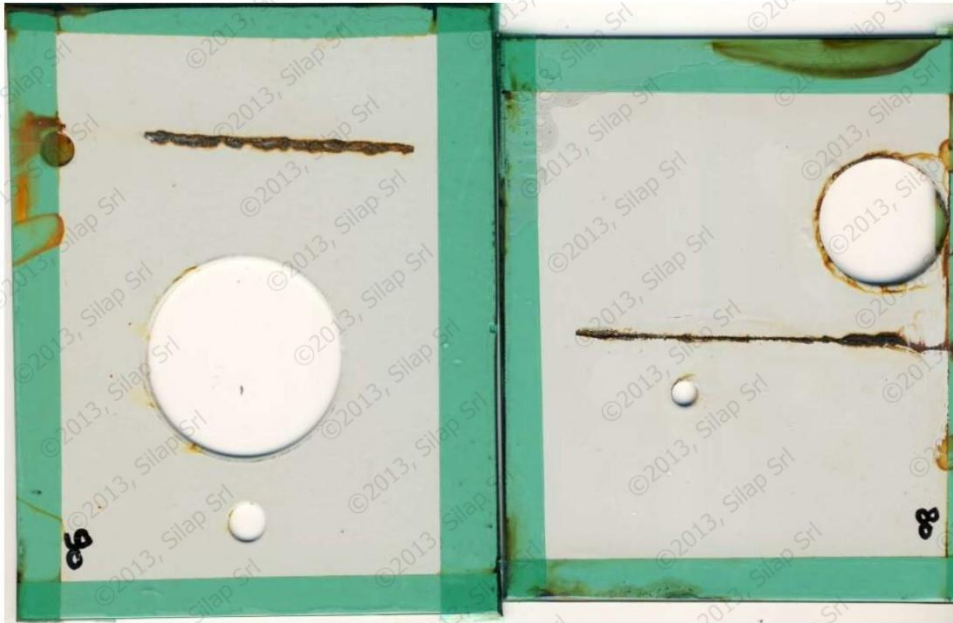
RESULT OF NEUTRAL SALT SPRAY FOG TEST AFTER 200 HOURS

The samples were tested for a total of 400 hours and were monitored periodically throughout the duration of the test.

Picture 6 - result of neutral salt spray fog test after 200 hours; on the left the sample B, on the right the sample A

The sample A has some slight blistering principle that the B sample coated with UV paint hasn't.

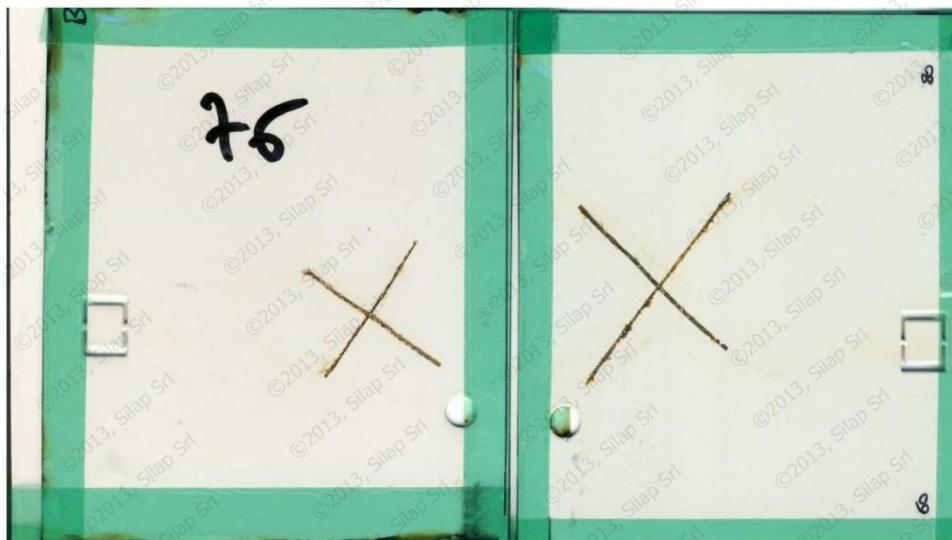
RESULT OF CONDITIONING MOISTURE TEST AFTER 200 HOURS

The samples were tested for a total of 1300 hours and were monitored periodically throughout the duration of the test.

Picture 7 - result of conditioning moisture test after 200 hours; on the left the sample B, on the right the sample A

- From the results gathered it can be seen as both samples exhibit a high degree of moisture resistance.
- In the non-engraved area doesn't appear defects in any of the 2 samples.
- Near the incision, both samples show the formation of bubbles (blistering).
- On the SAMPLE B there are many bubbles having a diameter of about 2 mm; On the SAMPLE A there are fewer than the SAMPLE B but any of these has a diameter of about 5 mm.
- We observe very little rust limited to the incision, which exposes the substrate.

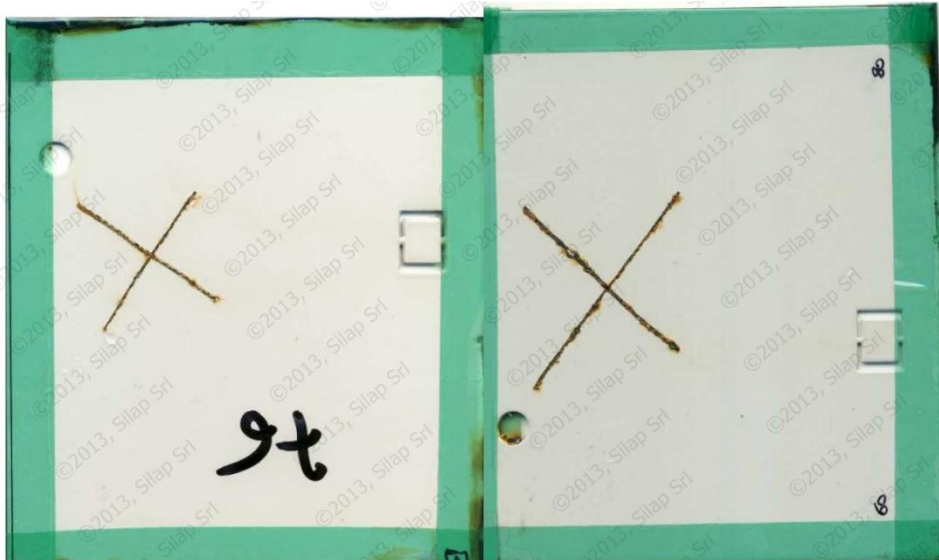
RESULT OF CONDITIONING MOISTURE TEST AFTER 400 HOURS

Picture 8 – result of conditioning moisture test after 400 hours; on the left the sample B, on the right the sample A

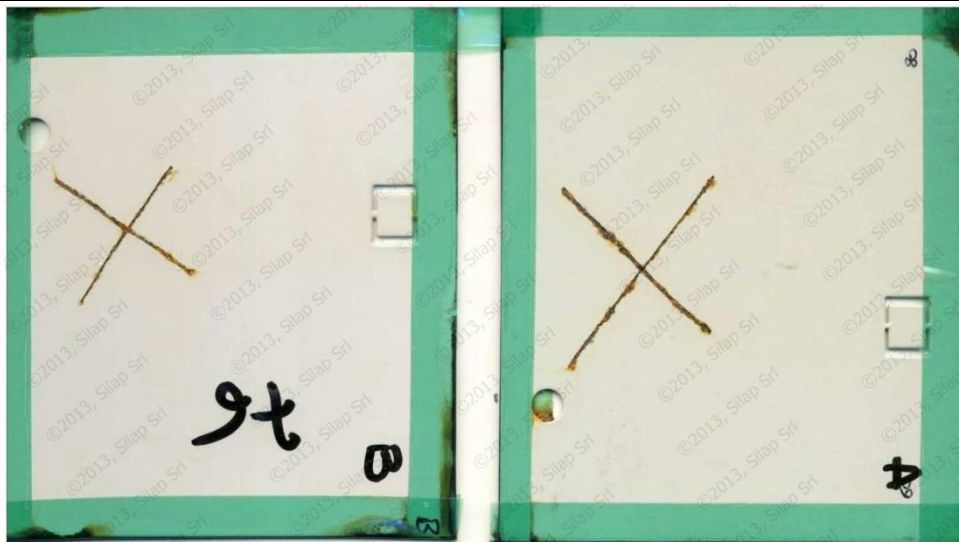
RESULT OF CONDITIONING MOISTURE TEST AFTER 627 HOURS

Picture 9 – result of conditioning moisture test after 627 hours; on the left the sample B, on the right the sample A
